INSTA-VALVE 250 **SUCCESS STORY**

Adding a Control Point in a Busy Intersection Without Disruption

Niskayuna, NY

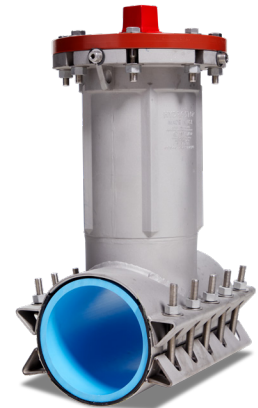
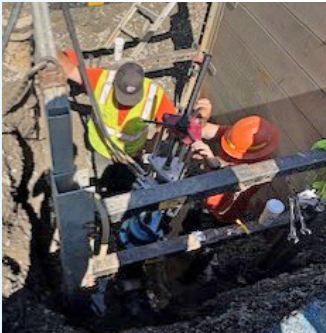
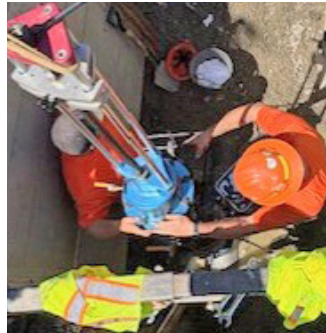
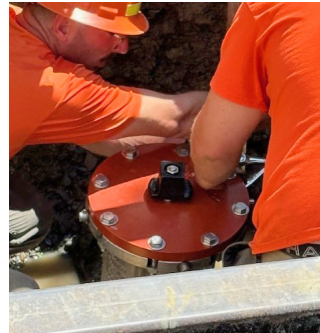
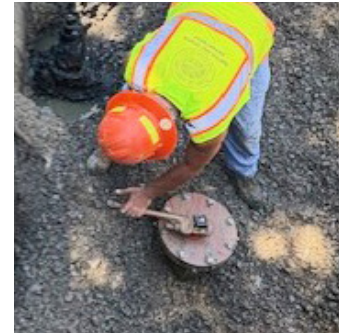
To overcome these challenges, Niskayuna's water department installed an 8" Hydra-Stop Insta-Valve 250. The team completed both excavation and installation within the same day, a necessary approach due to heavy traffic and site constraints.

The no-shutdown capability of the Insta-Valve 250 allowed crews to install the new valve while maintaining continuous service to local businesses, the school, and nearby residents. Despite the tight workspace and proximity to the gas main, the installation proceeded smoothly and safely, demonstrating the valve's adaptability in complex field conditions.
